REPORT  
ON THE WRECK OF THE  
SS RICHARD MONTGOMERY

Maritime and Coastguard Agency  
Spring Place  
105 Commercial Road  
Southampton  
SO15 1EG

March 2000

### PART 2 THE 1999 SURVEY OF THE WRECK OF THE SS RICHARD MONTGOMERY

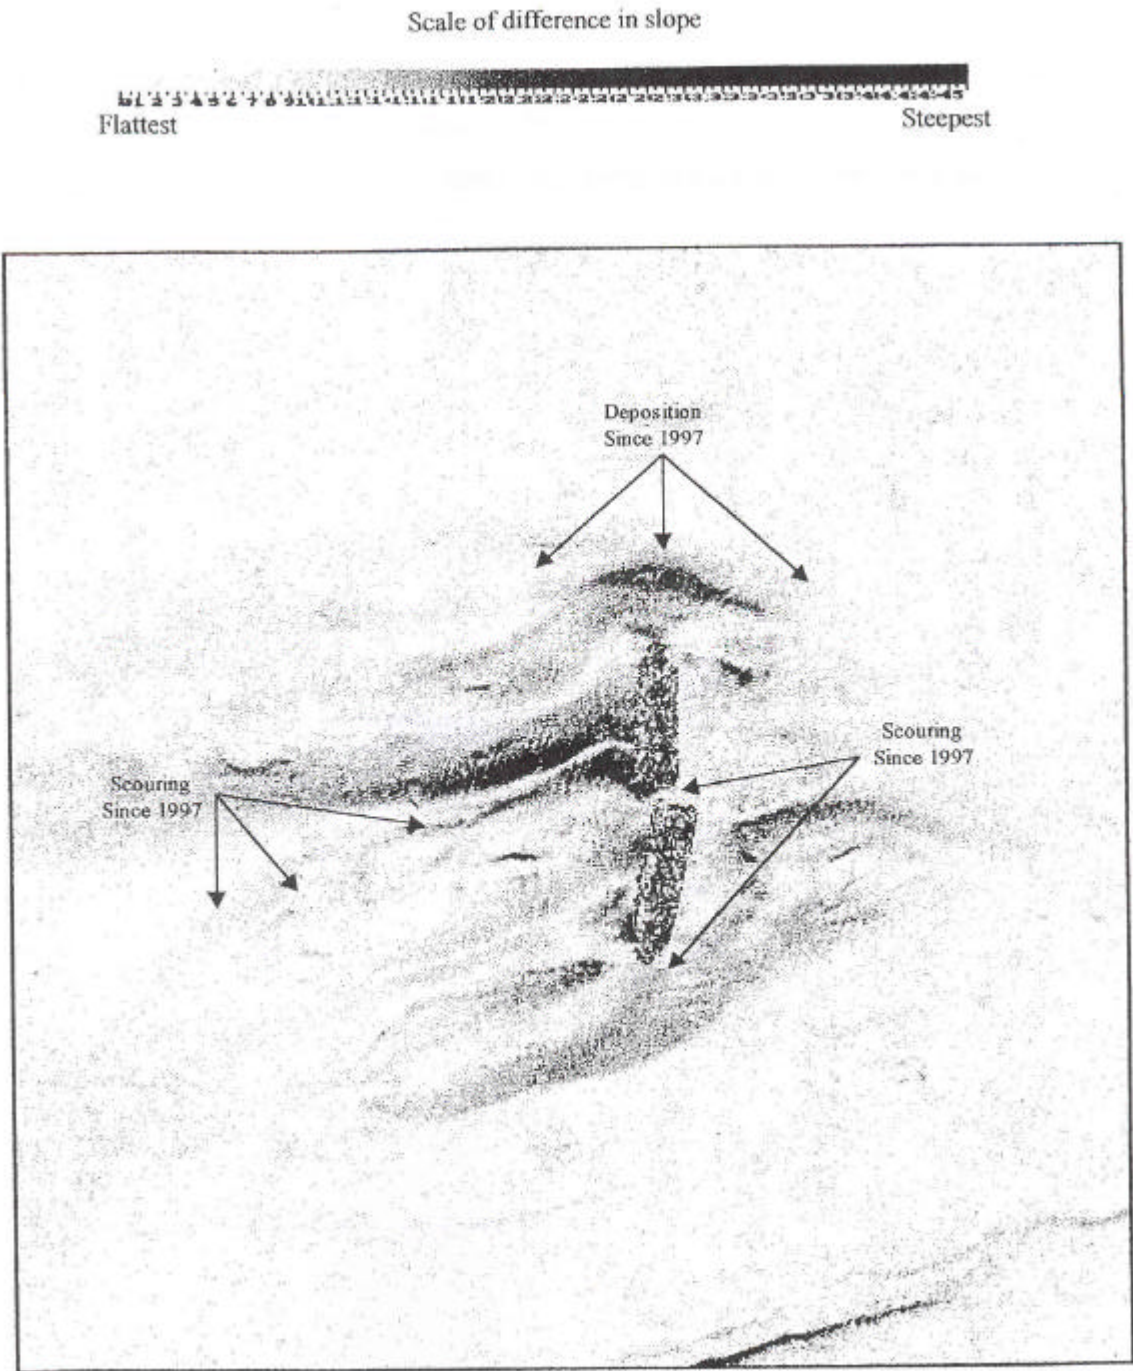
MONOCHROMATIC GRADIENT PLOT 1998

13. The monochromatic gradient plots in Appendix 3 reveal details of the ship's structure. These plots also reveal details of small seabed topographical features such as sand ripples over the area.

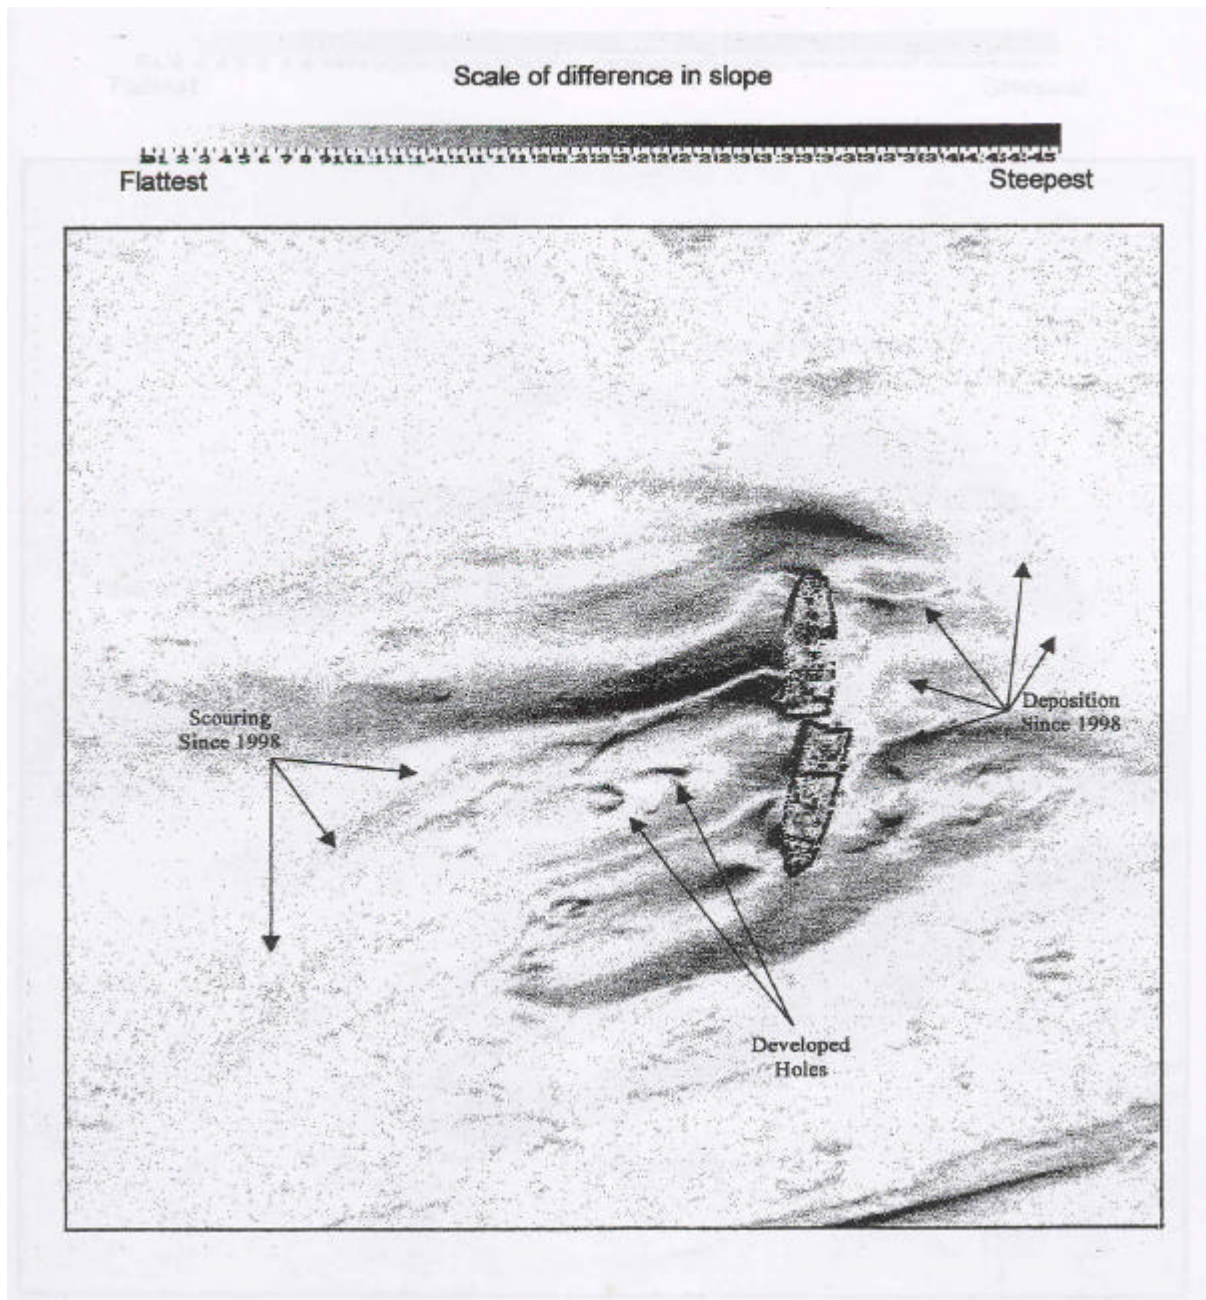
# MONOCHROMATIC GRADIENT PLOT 1999

18. No significant changes in position or orientation of the wreck were observed. The following points were noted:
- The crack in the starboard side of the forward section has again been detected. The crack in the port side of the forward section, detected in earlier surveys was not found although its presence could not be eliminated

19. The inspection of the wreck shows that there has been no significant change in the structure below surface. An object has fallen from the superstructure on to the seabed, and 2 large holes have been observed on the seabed to the west of the aft section of the wreck.
