REPORT  
ON THE WRECK OF THE  
SS RICHARD MONTGOMERY

Maritime and Coastguard Agency  
Spring Place  
105 Commercial Road  
Southampton  
SO15 1EG

March 2000

### PART 2 THE 1999 SURVEY OF THE WRECK OF THE SS RICHARD MONTGOMERY

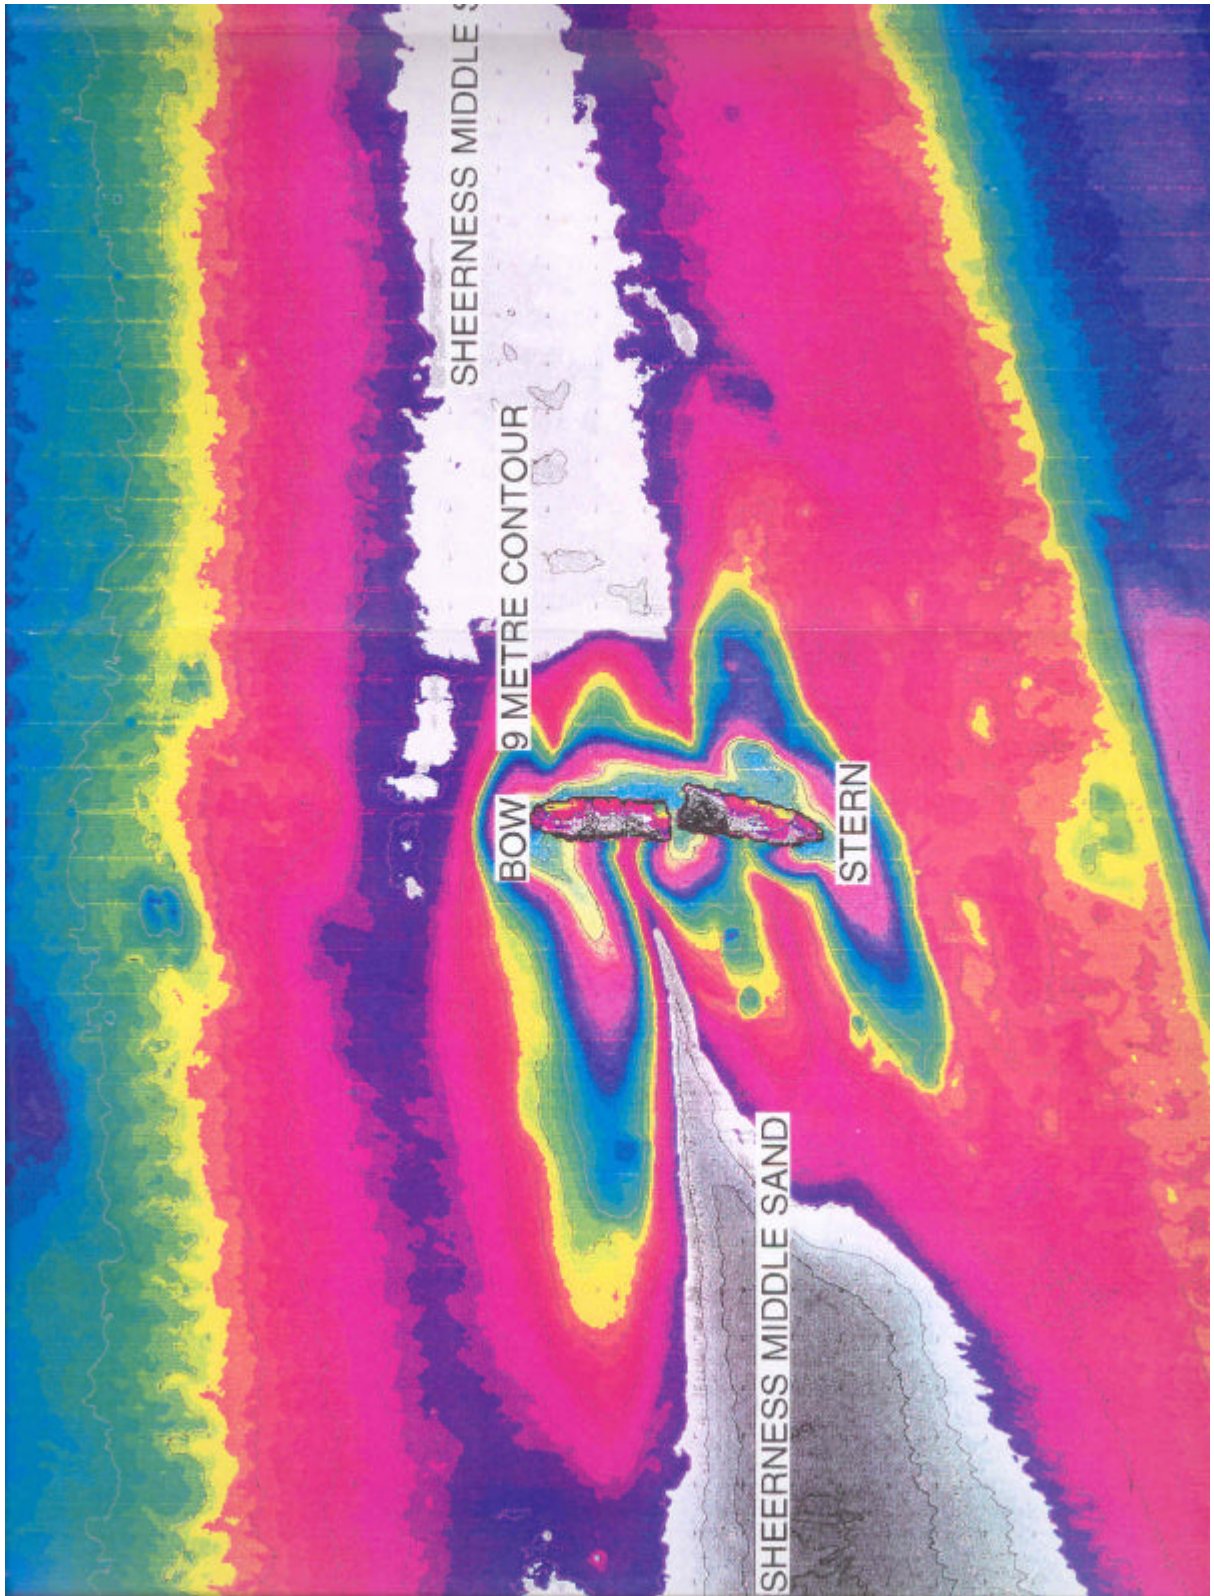
# MONOCHROMATIC GRADIENT PLOT 1999

76. The sonar surveys of recent years have produced repeatable data. They have identified some movement in the debris overhanging the vessel's sides. This indicates that any survey requiring manual intervention would be extremely dangerous. Although the seabed surrounding the wreck appears to be in a stable condition, some scouring and other structural changes do occur.
